# Insulating Concrete Forms as a Blast Resistant Building Material

**Force Protection Equipment Demonstration  
May 6, 7 & 8, 2003  
Quantico Marine Corps Base**

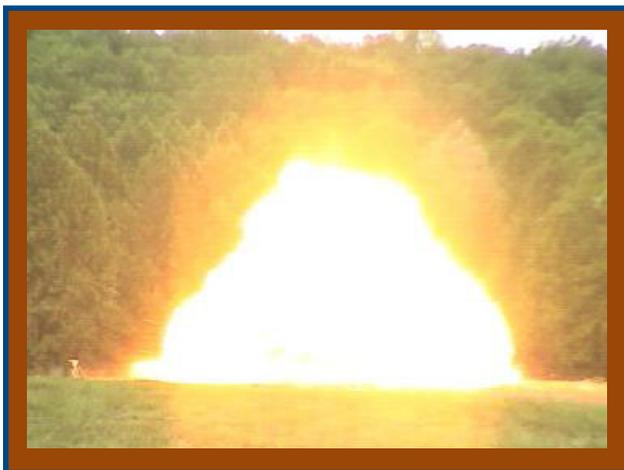
*Image 1 - Blast on third day*

blast wall. In addition to the initial blast, the boxes experienced an additional force created from the initial blast rebounding off of the steel wall. During the blasts, the TNT created a huge fireball as the explosion sucked the oxygen out of the surrounding area to fuel its destruction. (See image 1.) Therefore, the closest specimens faced an incredible quantity of destructive force. Since the explosion decimated the concrete bolster, the location of the charge had to be moved every day. (See image 2.)

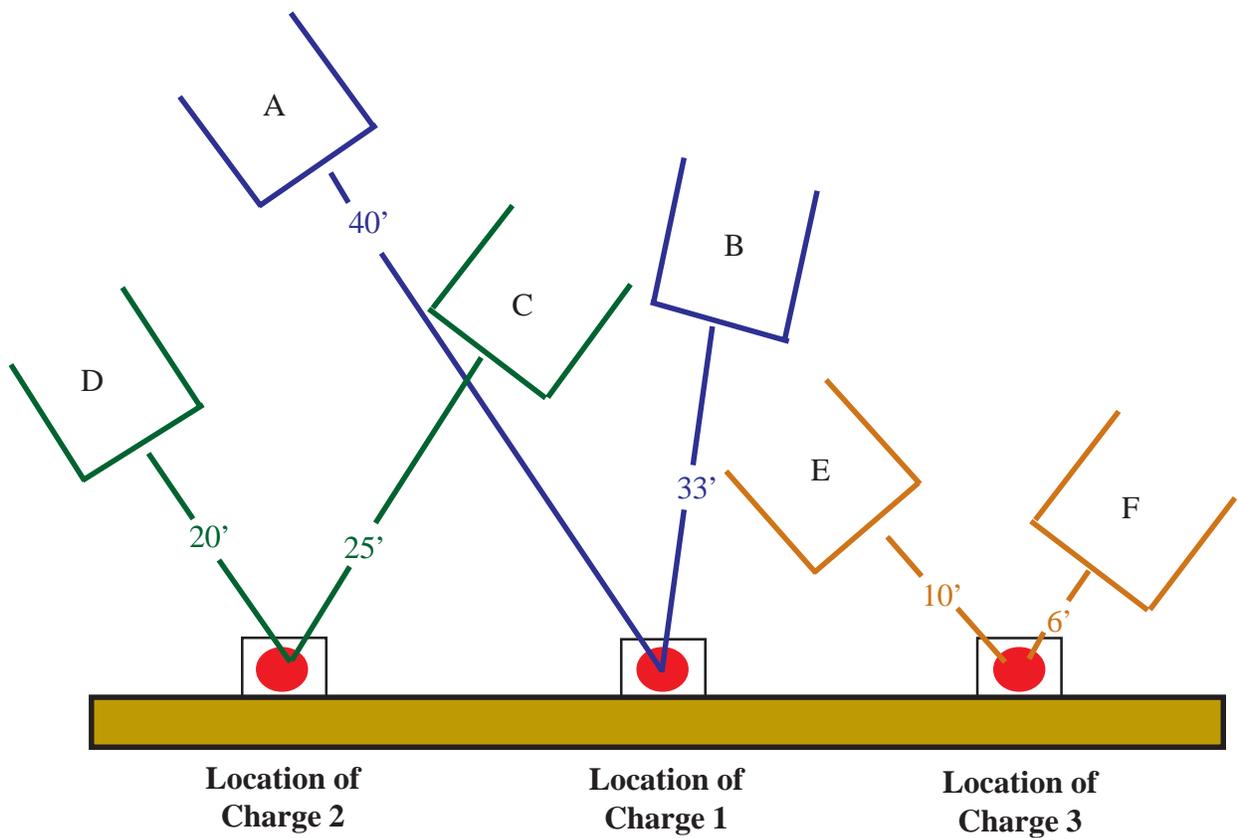
**Figure 1** – Plan of the test. The standoff distance between the charge and the specimens ranged from 6’ to 40’. Each day, two specimens were tested after which they were analyzed and then removed.

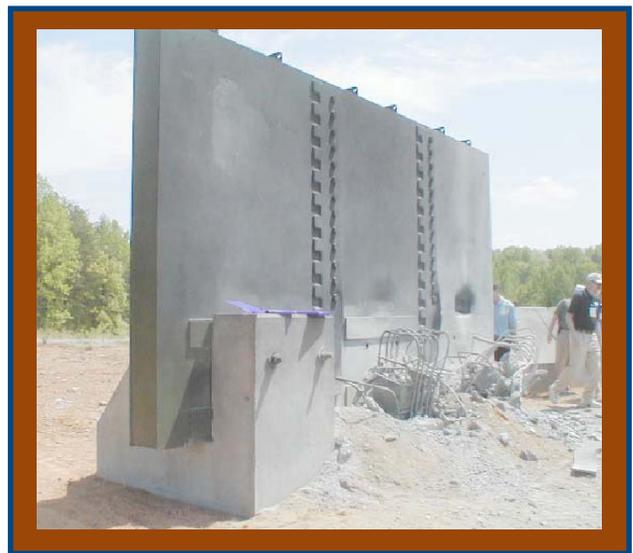
*Image 3 - Location of explosive charges*

**Image 3** – Since the TNT charge decimated the concrete bolster on which it was sitting, the TNT charge was placed on a different bolster each day. This photograph was taken after the second day. The bolster to be used on the third day can be seen in the foreground. (The charge will be placed where the blue folder in the photograph is located.) The remnants of the bolsters used on the first and second day can be seen along the center and right side of the wall. The rebar in the bolsters is #7. Damage to the blast wall itself can also be observed behind the sites of the first and second charges.

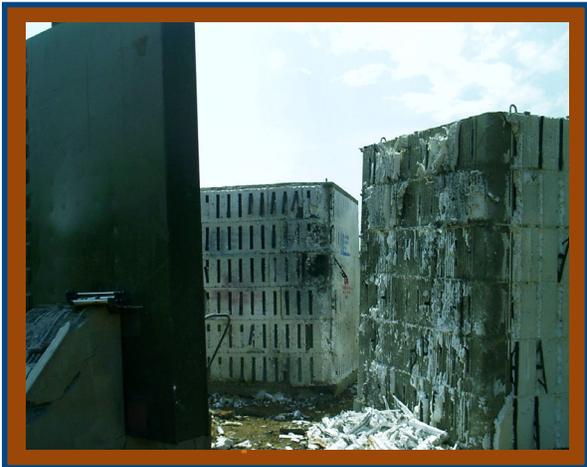
*Image 4 - Blast area on May 8, 2003*

**Image 4** – Specimens E (left) and F (right). Signs of compression of the EPS can be seen in the wall facing the blast of Specimen E. (Note how the ribs are only seen on the side facing the blast.) Embedded shrapnel can be seen on the bottom of Specimen E. Also, although exposed, no damage was seen to the edge of the upper slab. Reaction Box F had the closest standoff distance to the charge. The EPS was severely damaged, but the concrete maintained its structural integrity.

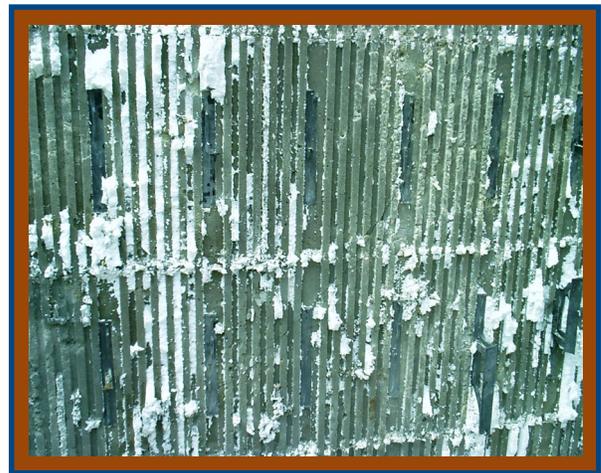
*Image 5 - ICF wall at six feet*

**Image 5** - A close-up of the ICF wall at six feet stand-off distance.
